**CALSPAN ON-SITE AIR BAG/ARM FRACTURE
CRASH INVESTIGATION**

CALSPAN CASE NO. 94-42

VEHICLE #1 - 1991 DODGE SPIRIT

VEHICLE #2 - 1985 FORD TEMPO GL

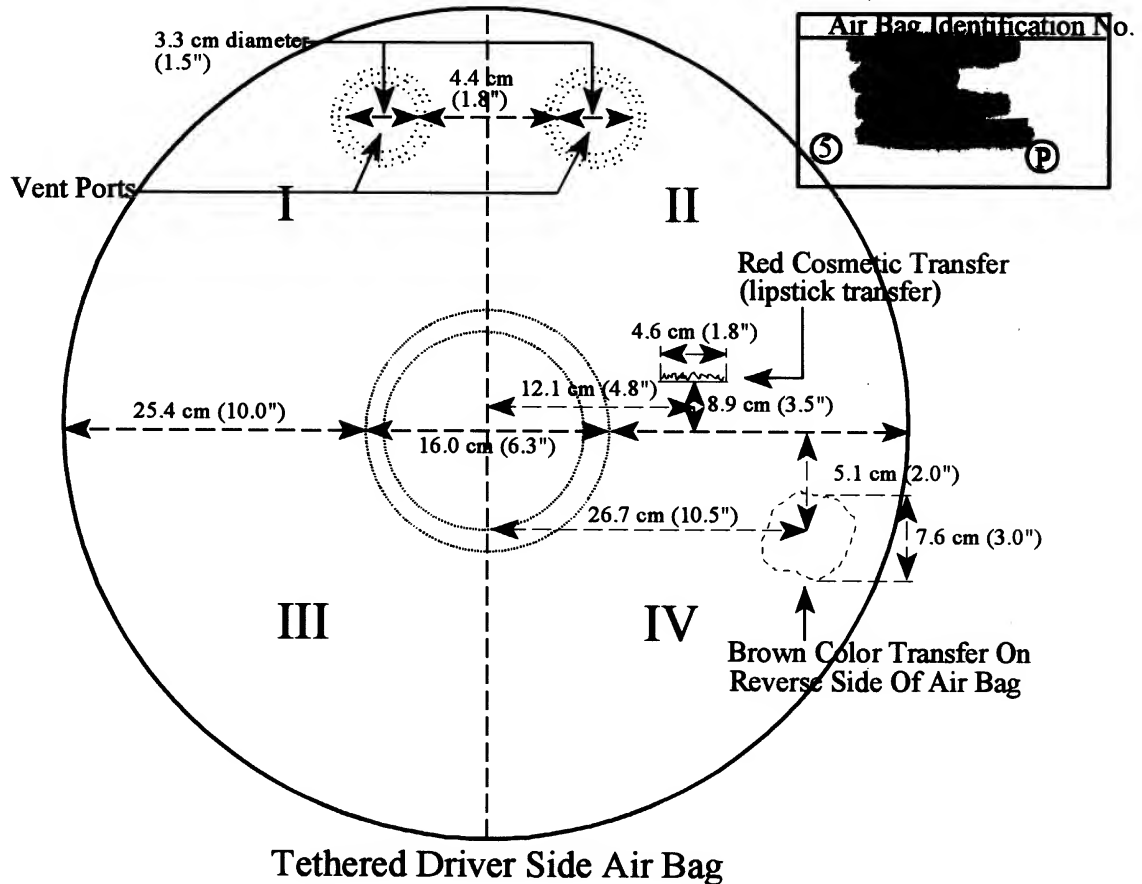
Figure 1

A light red cosmetic transfer (i.e., lipstick transfer) was noted in quadrant II (i.e., upper right quadrant). This transfer was 4.6 cm (1.8") in length and was located 12.1 cm (4.8") right of center and 8.9 cm (3.5") above quadrant IV (refer to Figure 1. on page 10 and photograph #41). A light

brown transfer was observed on the instrument panel side of the air bag which was attributed to post crash contact by rescue/tow personnel. The air bag identification data stamped on the instrument panel side of the air bag adjacent to the vent ports is listed in Figure 1.

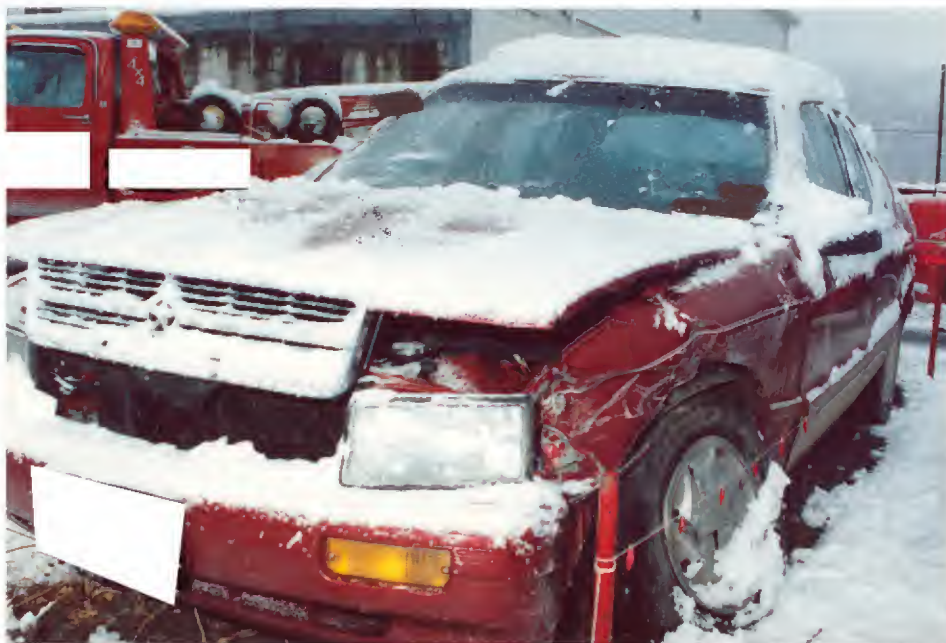
16. Overhead view of the lateral crush pattern along the left front fender.

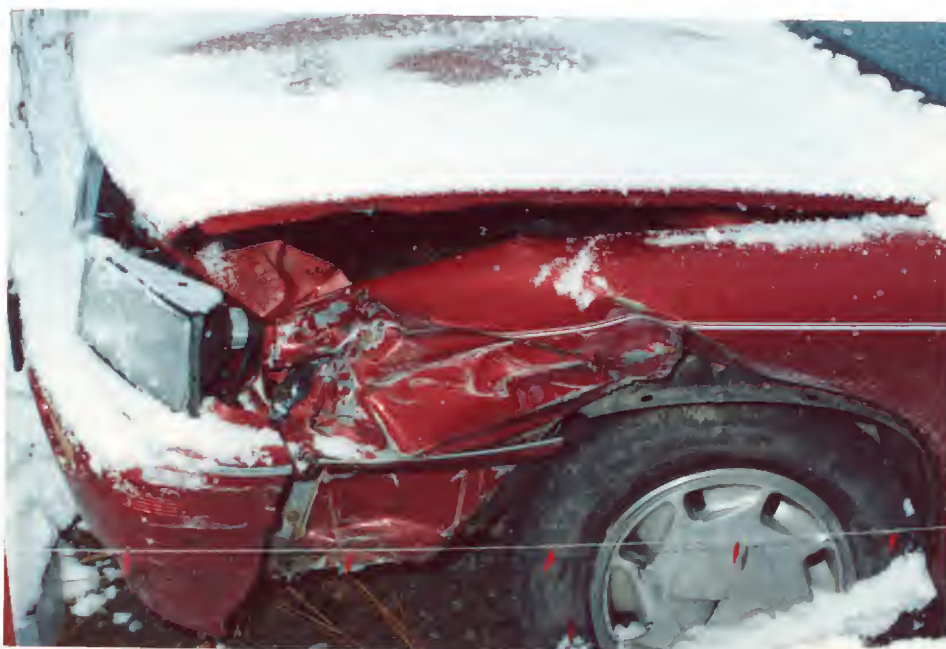
17. A view of the left front corner of Vehicle #1 showing the area of contact damage.

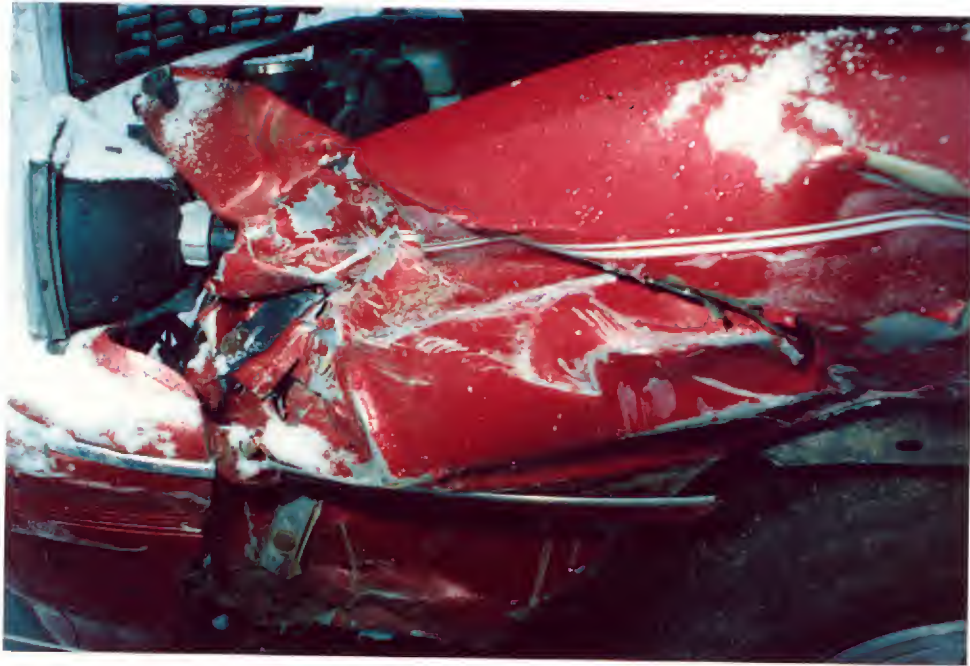
18. A lateral view of the left front fender showing the area of contact damage.

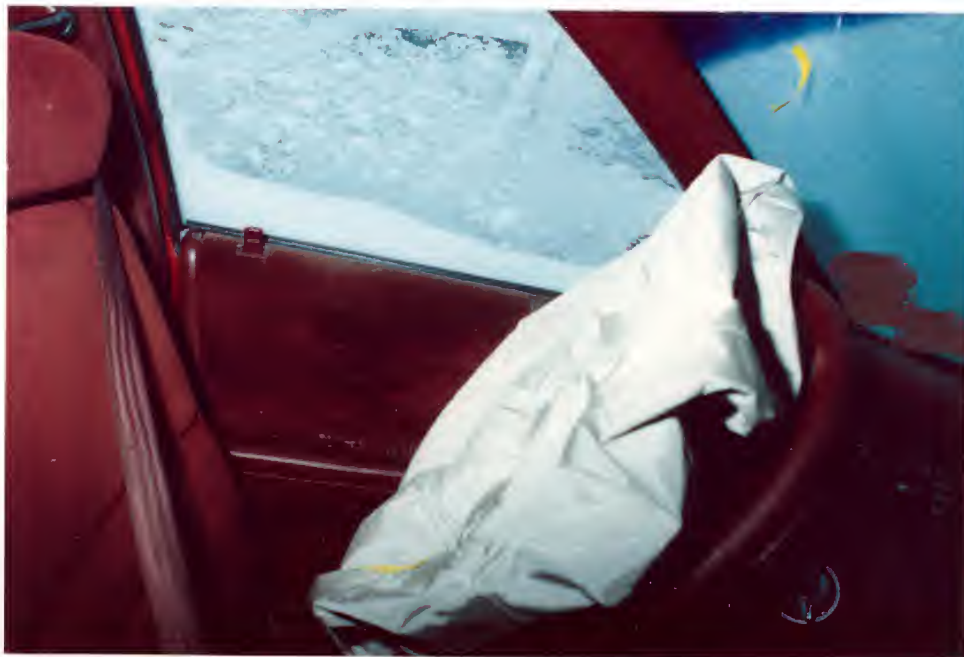
41. View of a light red transfer (i.e., lipstick) in the upper right quadrant of the air bag.

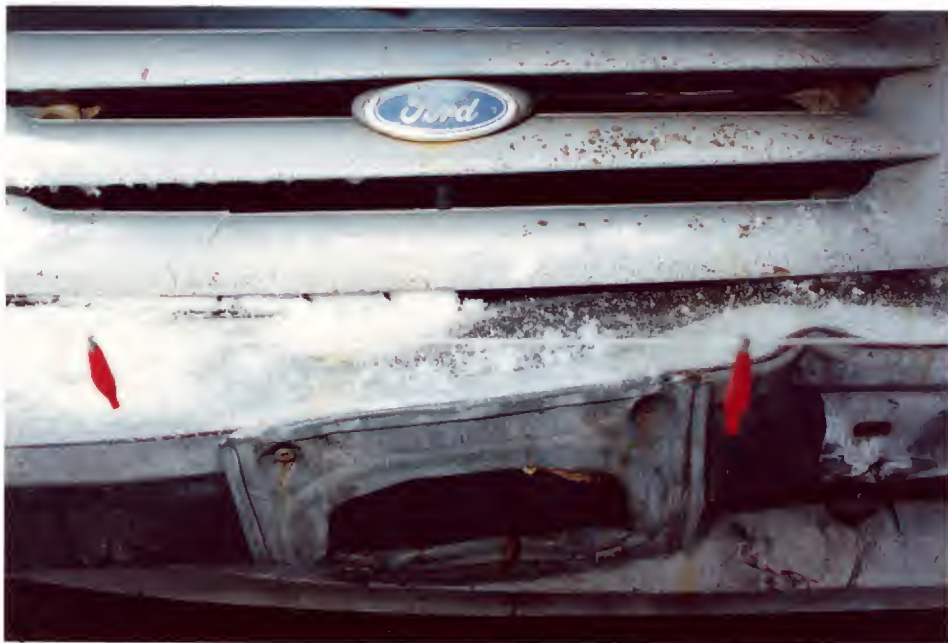
55. Frontal view of the Vehicle #2 (1985 Ford Tempo GL) showing contact damage resulting from the impact with Vehicle #1.

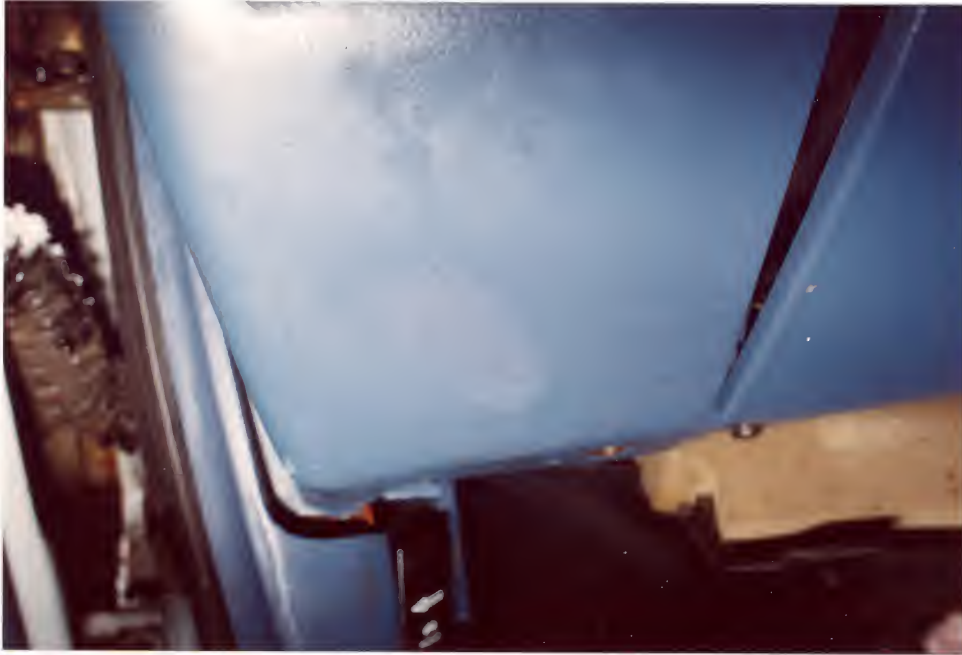
72. View of the lower instrument panel showing a scuff mark below the headlight switch from the driver's left knee.

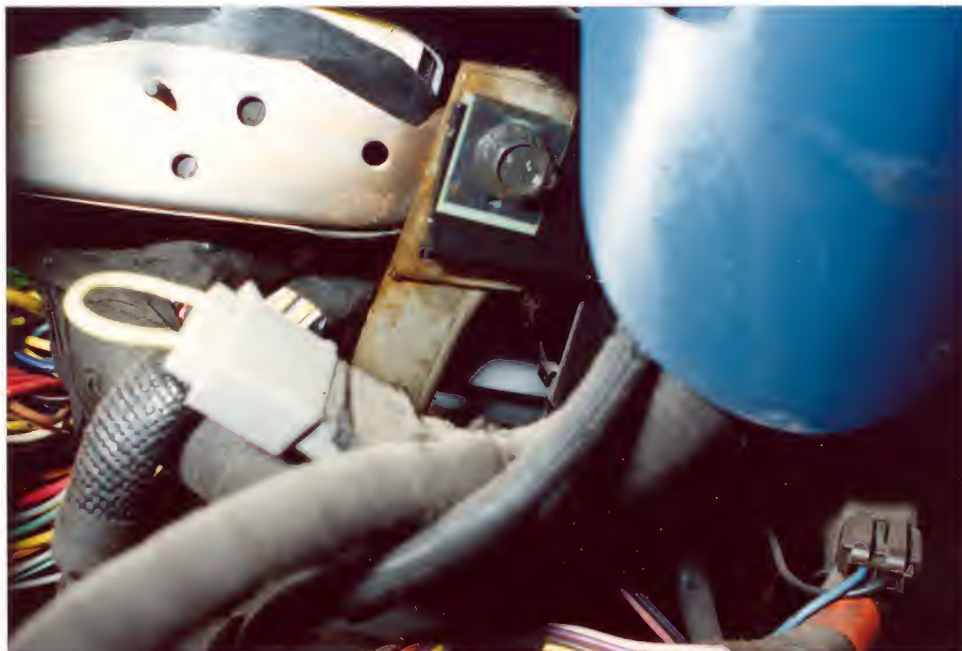
73. A close-up view of the scuff mark on the lower instrument panel by the driver's right knee.
